PARK RIVER BASIN
WEST HARTFORD, CONNECTICUT

HARTFORD RESERVOIR NO. 1 DAM
CT 00001

PHASE I INSPECTION REPORT
NATIONAL DAM INSPECTION PROGRAM

APRIL 1980

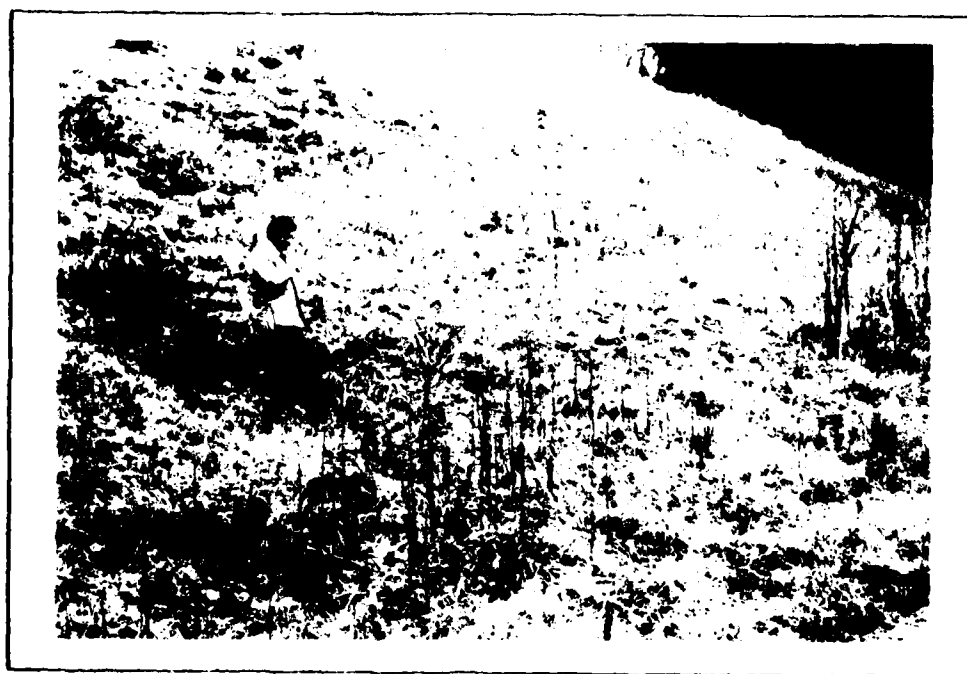
A permanently saturated condition exists at the downstream toe which has been partially corrected with the installation of a portion of the toe drain system. An undulated area was observed at the downstream toe of the dam, near the location where toe drains were installed in 1978. It could not be determined if the area was undulated as a result of the toe drain installation or because of embankment displacement. A depression of the downstream face which follows the alignment of the outlet pipes and extends from the crest to the toe of the dam was also observed during the inspection. This depression appears to be a result of improper compaction around the outlet pipes. However, seepage could have been a contributing factor.

2. DOWNSTREAM FACE OF THE DAM SHOWING VEGETATIVE COVER AND A DEPRESSION IN THE EARTH EMBANKMENT. (11/13/79)

The Owner should implement the following operation and maintenance measures: (1) Complete all work on the toe drain system; (2) the disturbed area at the downstream toe of the dam and the depression in the downstream face should be regraded and reseeded and monitored for future movement; (3) The stone riprap on the upstream face of the dam should be replaced where necessary; (4) Animal burrows on the downstream face of the dam should be backfilled; (5) A formal flood warning plan should be developed; and (6) a program of annual periodic technical inspection should be instituted.

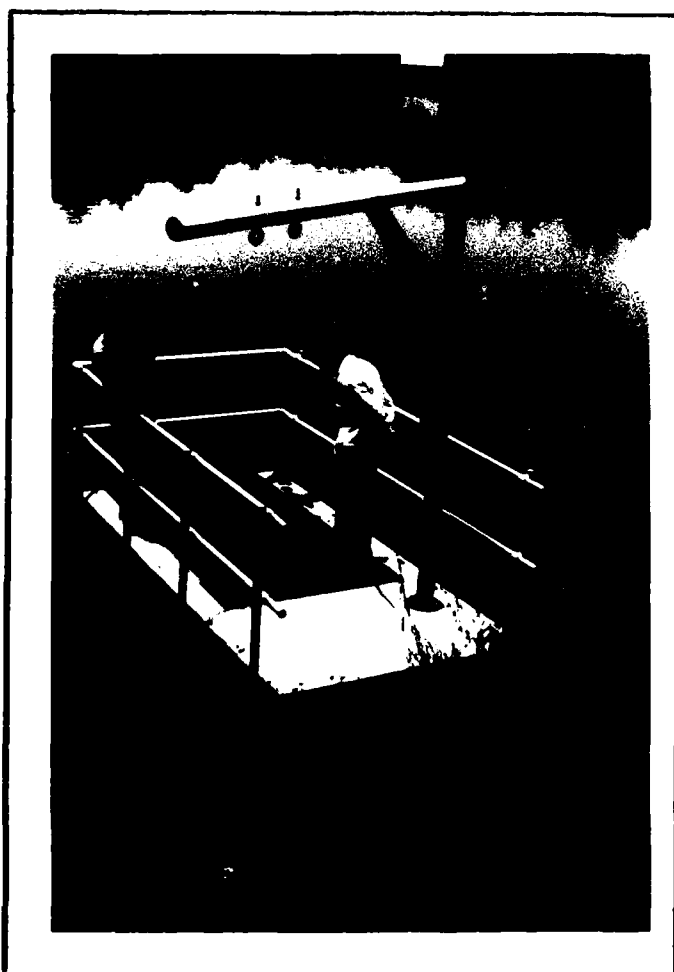
6. RECENTLY RECONSTRUCTED INLET FOR THE POWER HOUSE WATER SUPPLY PIPE. (11/13/79)

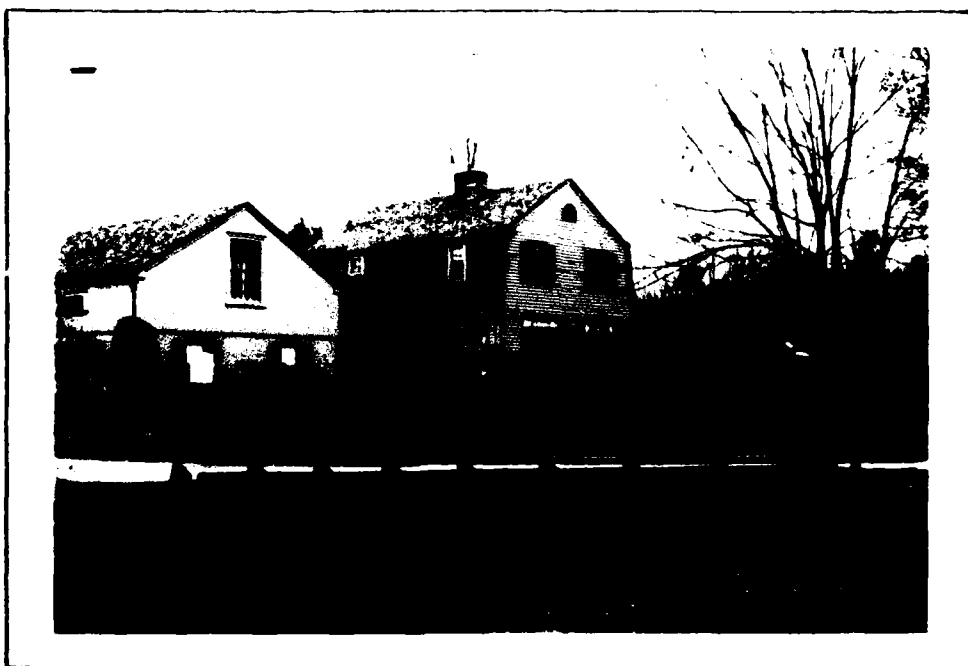
20. POTENTIAL DAMAGE AREA ABOUT 2.1 MILES DOWNSTREAM FROM THE DAM. (11/13/79)

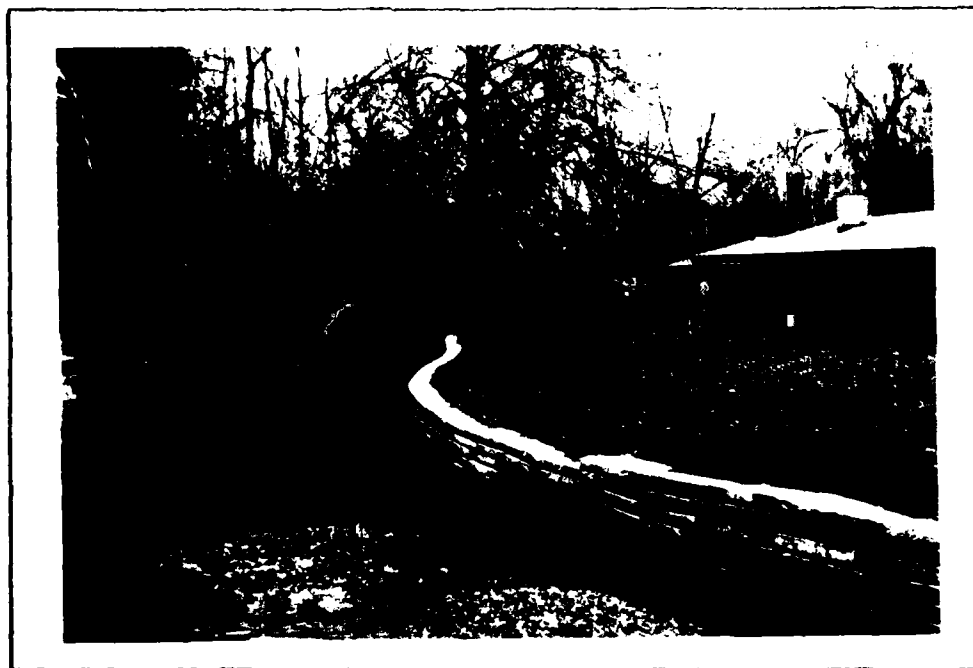
22. POTENTIAL DAMAGE AREA ABOUT 2.1 MILES DOWNSTREAM FROM THE DAM. (11/13/79)
